A study on failure characteristic of spherical pressure vessel

This paper reports an experimental investigation of the failure behavior of pressure vessels during high pressure of hydraulic loading. The pressure vessels were manufactured by two different procedures. One method is spin forming and tungsten inert gas (TIG) welding process and the other is blow forming and solid-state diffusion bonding process. The failure behavior has been studied and the effect of forming method has been analyzed. The result shows that the pressurization rate and the acoustic emission signal increasing rate provide a similar tendency for a vessel of integrity, while the signal increasing rate is much higher than the pressurization rate for a vessel with defects. It is clear that the acoustic emission response of the vessel to the pressure loading can be successfully applied to predict the structural integrity and failure behavior of the vessels manufactured with both methods.

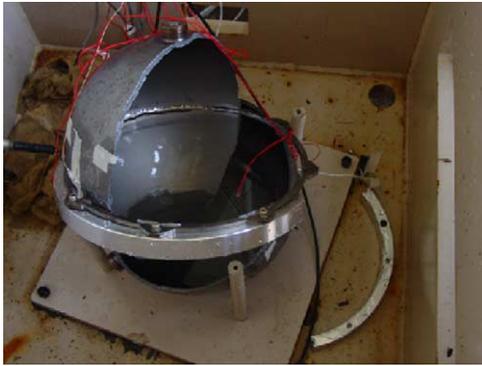
Fig. 7. Failure of attitude control tank ACT-02.

Fig. 7 shows the failure of the attitude control tank ACT-02 and the fracture starts at the weld region of the hemisphere propagating to the upper boss region. As the results of the pressurizing test and nondestructive test, the undercuts produce more stress concentration than porosities or a lack of filler, and it is important to remove all undercut defects if possible to increase the reliability of the tank.

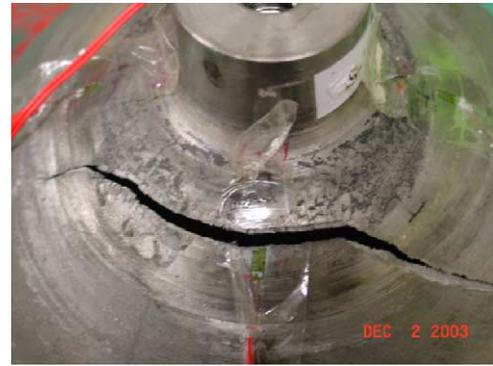
Fig. 9. Failure mode of valve driving tank.

The result of the pressurizing test of helium tank for valve driving is depicted in Fig. 9. As shown in Fig. 8(a) the failure occurred near the boss with the hydraulic pressure of 29.8 MPa, which is lower than maximum expected operating pressure (MEOP). This is because the thickness at this region is about 50% of the design thickness. Fig. 8(b and c)

presents the results of strain measurement from the boss area and the symmetric plane of upper and lower hemisphere with hydraulic loading time. It was shown that the boss area experienced higher deformation and the maximum strain was obtained at the location where fracture occurred. By increasing the hydraulic pressure linearly with time, the strain increases drastically after 26.2 MPa up to failure as shown in Fig. 8(c). The result of failed valve driving tank is shown in Fig. 9.
